# Estling Lake Dam Potential Failure Mode Analysis

**New Jersey Transit**

**October 2020**

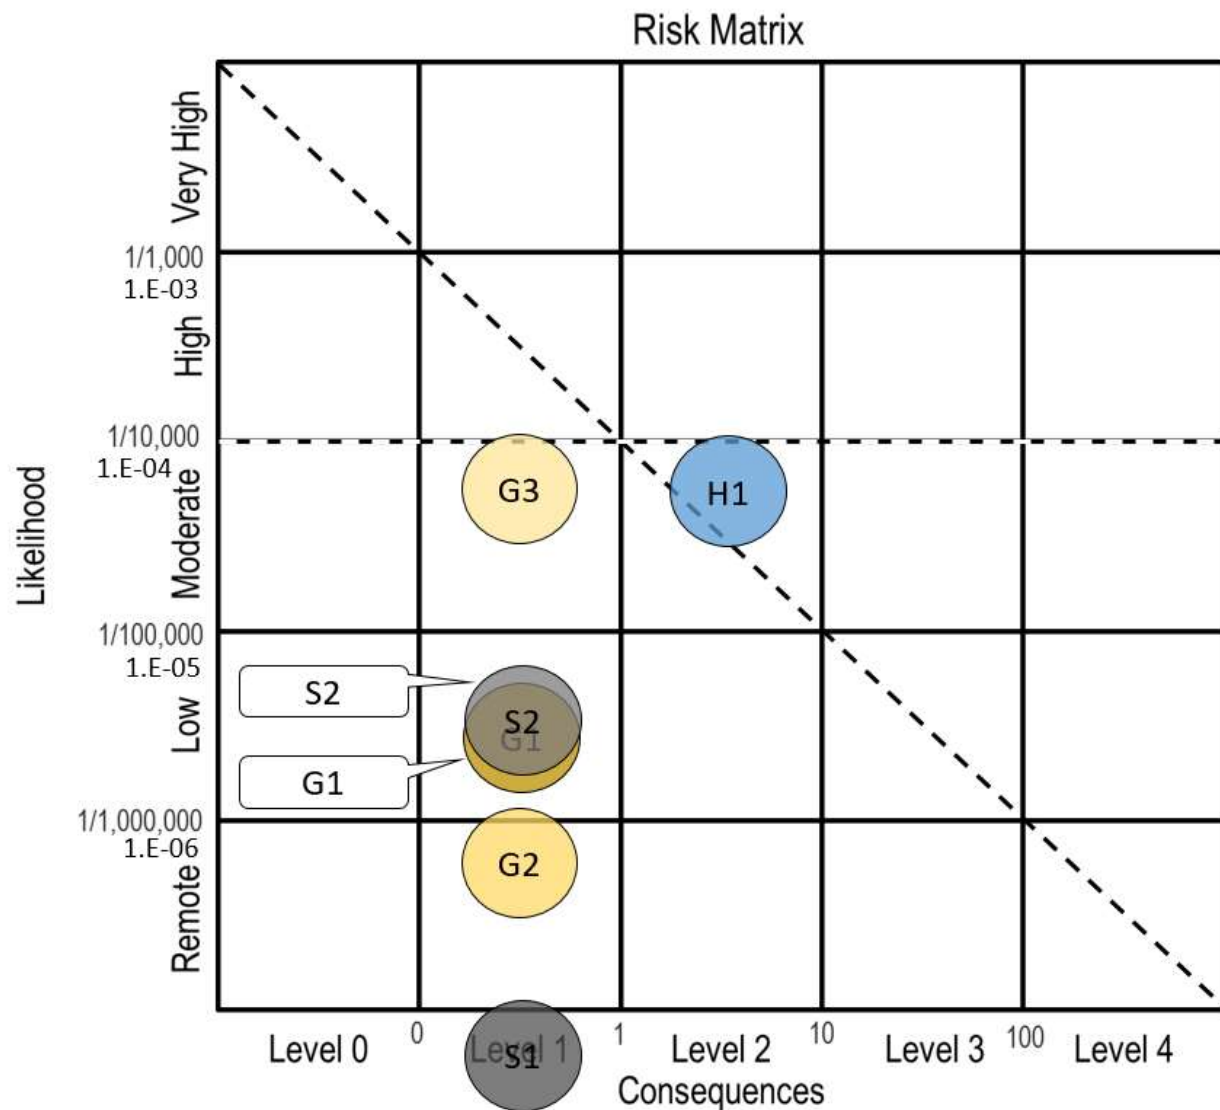
**Figure R-4. Risk Estimates**

Based on the discussion by the team, the resulting risk estimates for the six PFMs considered to be risk drivers are summarized on Figure R-4 below.
