# Estling Lake Dam Potential Failure Mode Analysis

**New Jersey Transit**

**October 2020**

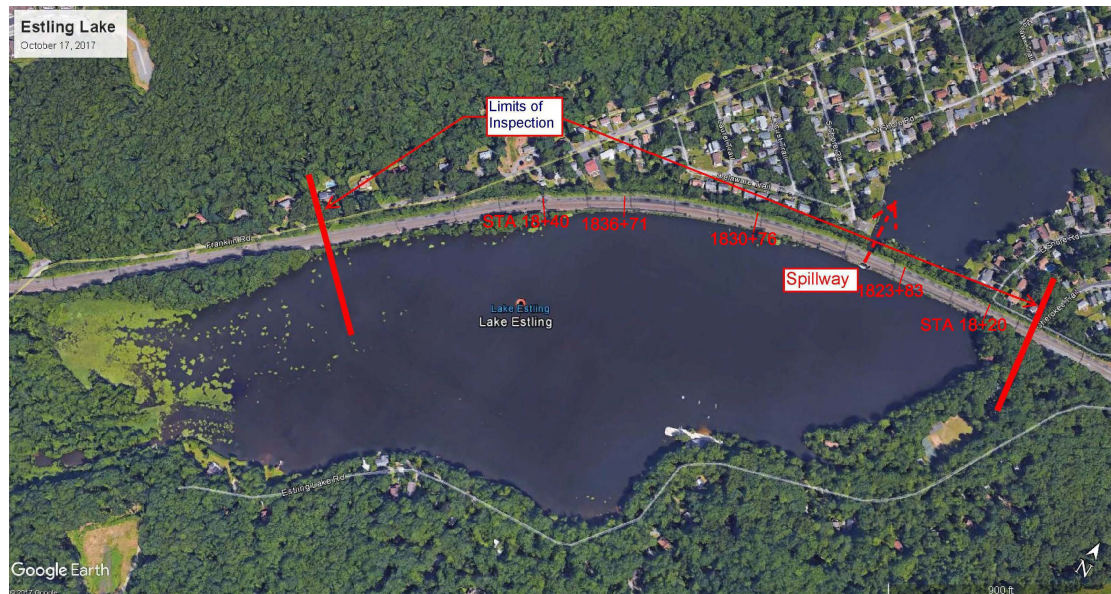
**Figure G-2. Estling Lake Limits of Inspection from Formal Inspection Report**

The spillway is centrally located on the embankment, and is comprised of an arched masonry design constructed of large granite blocks with a stepped box arrangement. The formal inspection report for the Estling Lake Dam indicated cracking was evident at the masonry spillway. Crack Mapping of the arched masonry spillway at Estling Lake Dam is included as Appendix B-1. A structural stability evaluation of the arched masonry spillway was performed as part of this report and expanded on in Section 5.0.

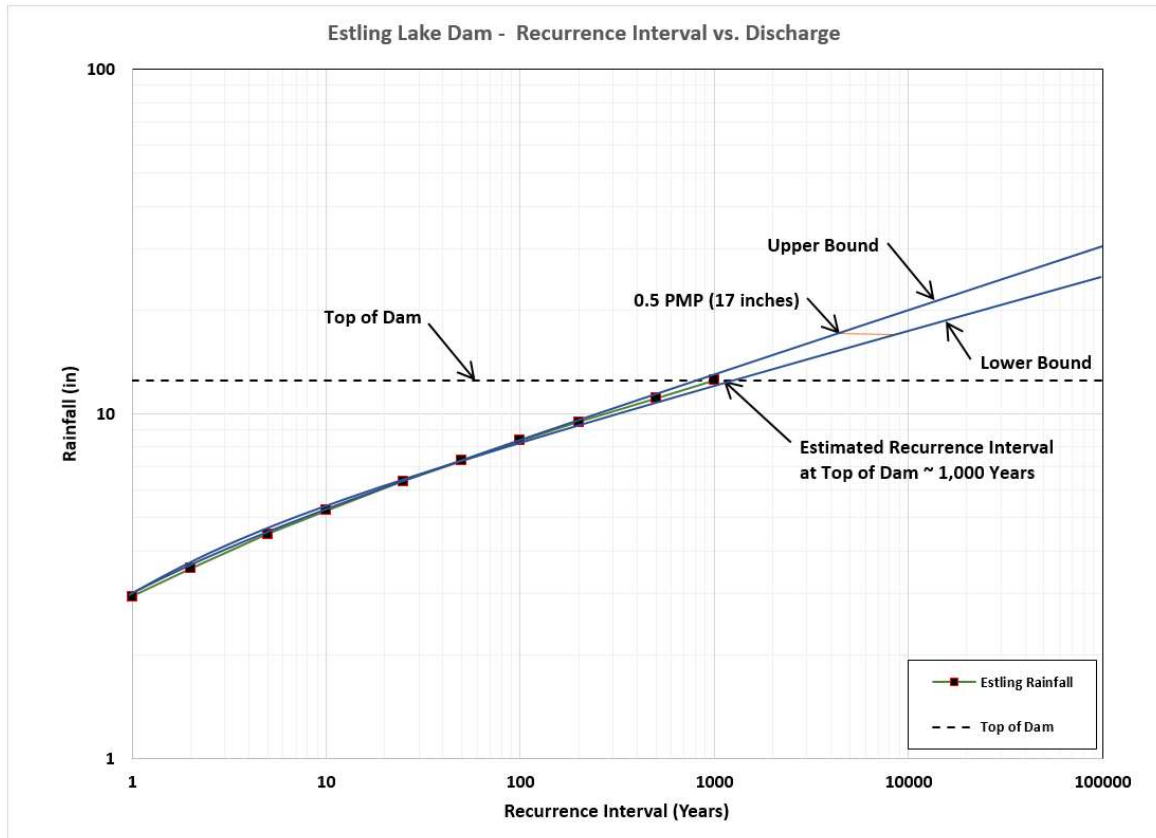
**Figure R-2. Hydrologic Loading Estimates**

The above-referenced H&H analyses formed the basis for updated estimates for inflow, outflow, and peak lake elevation for various flood events. To inform the team in estimating failure likelihoods, the team reviewed the spillway capacity and the resulting overtopping flows expected for the 0.4 and 0.5 Probable Maximum Precipitation (PMP) events. Inflow estimates for return period storms were plotted and extrapolated to extreme probabilities (i.e. 1E-06) and compared with the spillway capacity, as shown in Figure R-2.

This is considered to be a crude method for estimating extreme flood probabilities; however, there was no other credible data available. It is noted that for other dam safety studies, the PMP has been estimated to have a return period ranging from about 10,000 to over 1,000,000 years. Estimates performed for this study indicate that the spillway has capacity to pass a storm with a return period of approximately 1,000 years. The 0.5 PMP event is approximately a 5,000 - 9,000 year event. As noted above, this information was used to inform the PMFA team in developing likelihood of failure estimates; the team was given the latitude to consider the validity of these estimates.
